[Summary] Current Status of Shika Nuclear Power Station after the 2024 Noto Peninsula Earthquake (as of January 30)

Current Status of Shika Nuclear Power Station after the 2024 Noto Peninsula Earthquake (as of January 30)

Occurring Event and Status of Response up to the Present

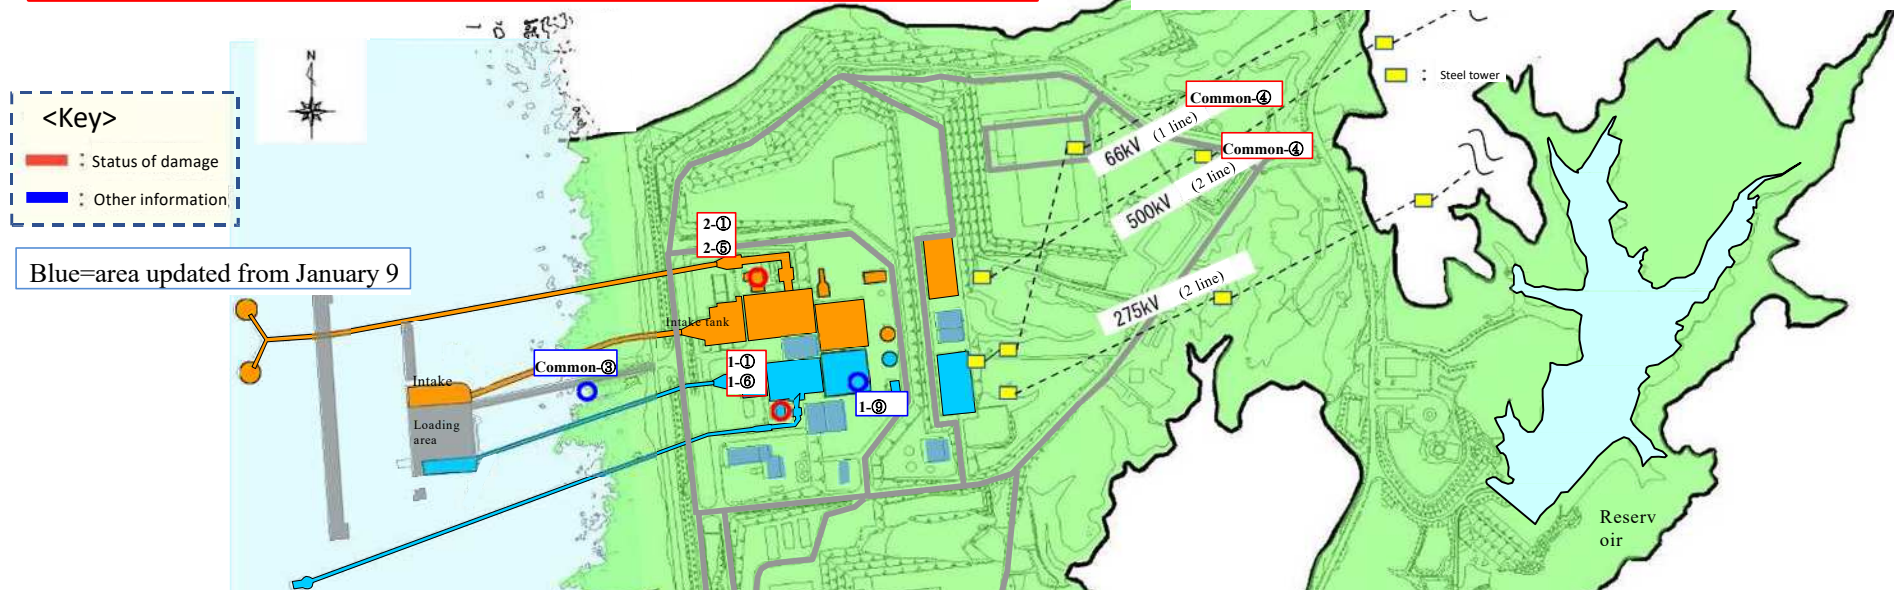
(Common-④)

Due to the malfunction of Unit 2 main transformer and the Naka Noto Substation Gas Insulated Switchgear (GIS) being partially damaged, two of the five off-site power transmission lines were compromised (Shika Naka Noto Line 500kV 2 lines), but three lines are still online.

Also, emergency diesel generators, high capacity power cars and high voltage power cars have been secured as emergency power sources.

⇒Necessary off-site power and emergency power sources have been secured, and there is no impact on nuclear safety, such as capabilities to cool spent fuel, etc.

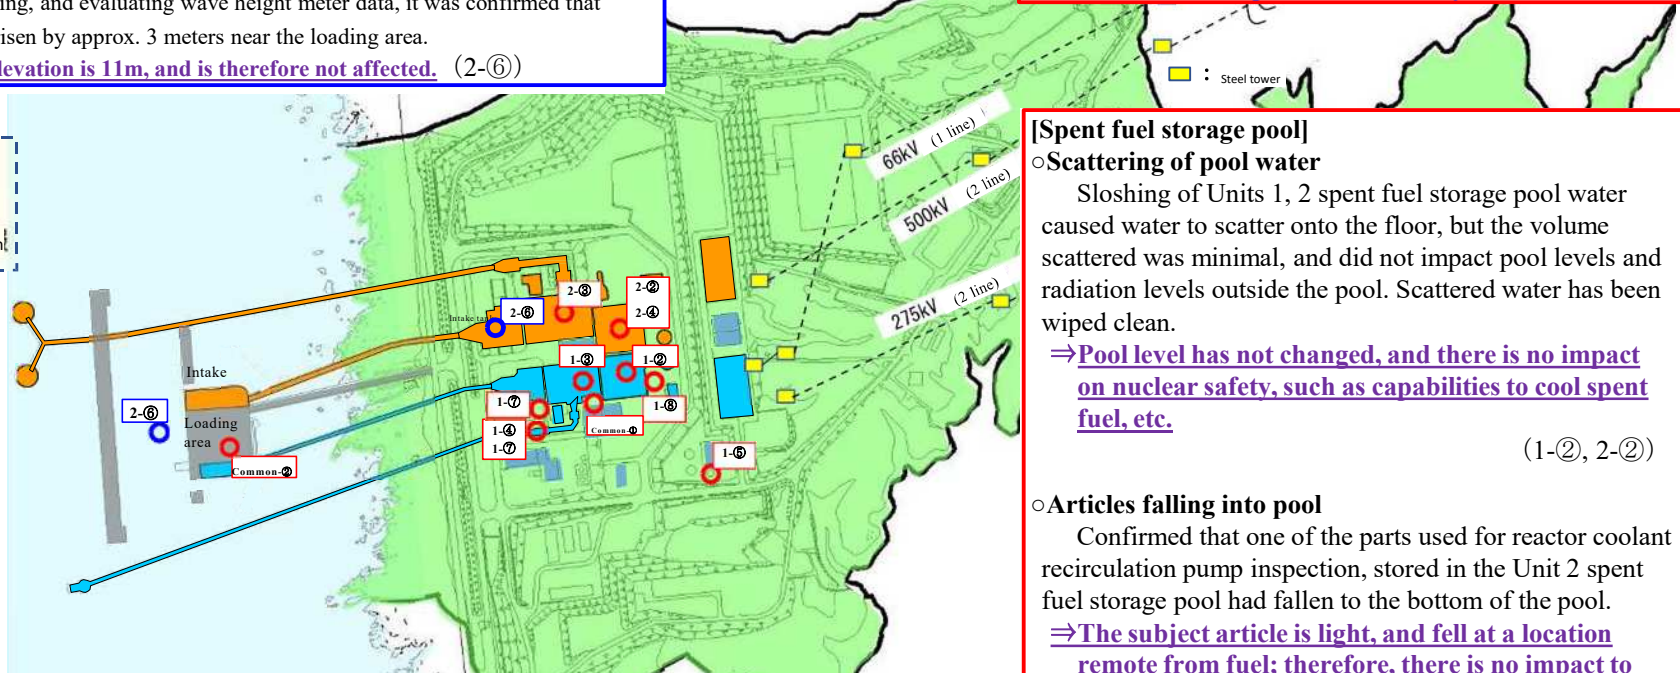
○ **Subsidence and inclination, etc.**

Subsidence has occurred in paved concrete at the reclaimed loading area (common- ②), Unit 1 discharge tank and Unit 1 component cooling discharge connection tank seawall foundation (1- ⑦), location where Unit 1 high voltage power car is used (1- ⑧); and inclination of Unit 1 discharge tank sea wall (1-④), Units 1, 2 waste treatment building expansion joint seal cover becoming detached (common- ①) had also occurred.

⇒ All of the equipment satisfied the necessary functions, the damage was minor, and there are no problems with safety or use.
